# ROCKFALL PROTECTION

## CASE STUDY:

### Kaikoura SH1 Rockfall/ Shallow Slips Protection: Site SR32

JULY 2017

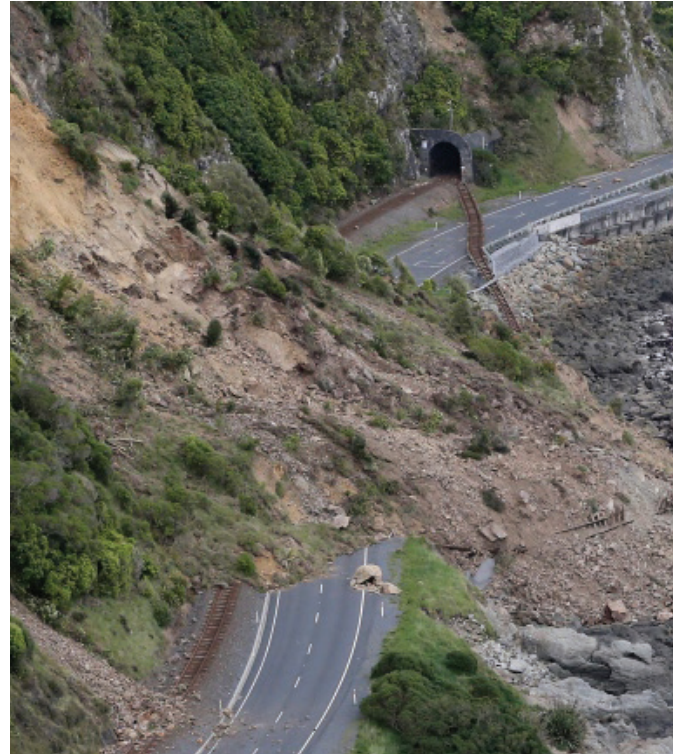
**A typical scene of road inundated with a landslide along the SH1**

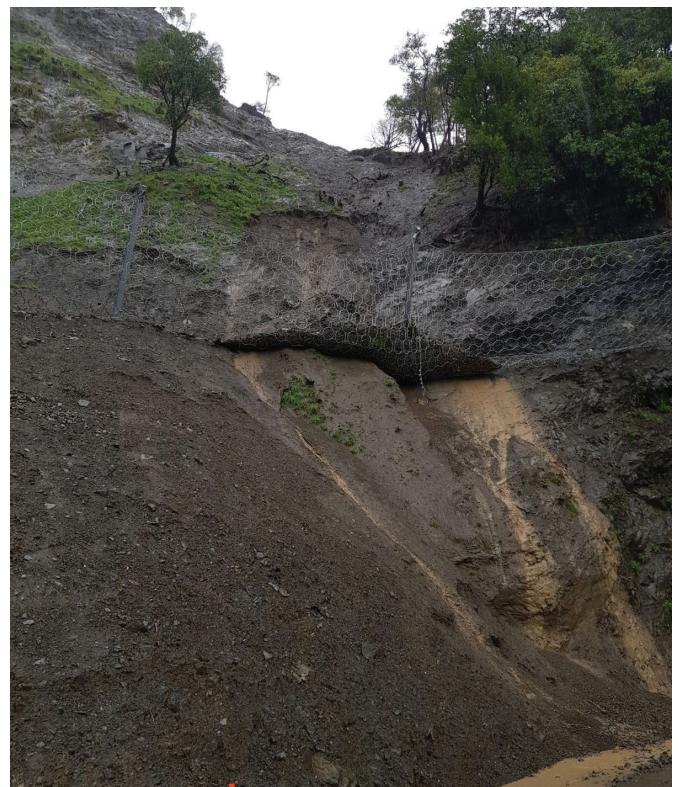
**RMC200A Fence**

They are all installed on the slope profile above the road level. Not long after the fence installation before the road reopened, one of the fences was hit by a shallow landslide with an estimated volume of approximately 15m<sup>3</sup> and successfully arrested. The impact energy didn't cause any significant damage to the fence and this debris was later cleared by the contractor.

Arrested estimated volume of 15m<sup>3</sup> of shallow landslide debris end of 2017. Image courtesy of Rock Control Ltd.

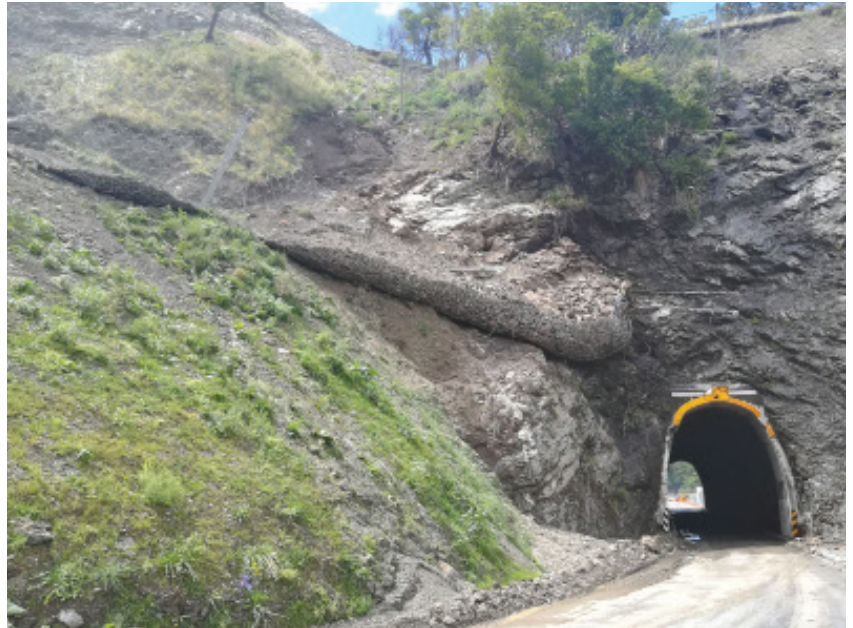
**RMC200A Fence**

On 20th Feb 2018, the Kaikoura region was badly affected by ex-cyclone Gita. This resulted in further landslides along the coastal transport corridor. Site 32 was not exempted from the damage done by ex-cyclone Gita where an estimation of 200 tons of rocks and saturated soil debris collapsed from the upper slope source area. The entire volume of debris impacted one of the fences and was successfully arrested by the fence. The fence was originally designed for rockfall impact but in this instance the fence has demonstrated its ability to intersect a shallow land slips or debris flow situation.

Impacted fence after ex-cyclone Gita Feb 2018

The debris was later remove by the specialist contractor - Rock Control Ltd and the fence reconstructed to meet its intended function for another potential impact to protect the rail and road infrastructure.

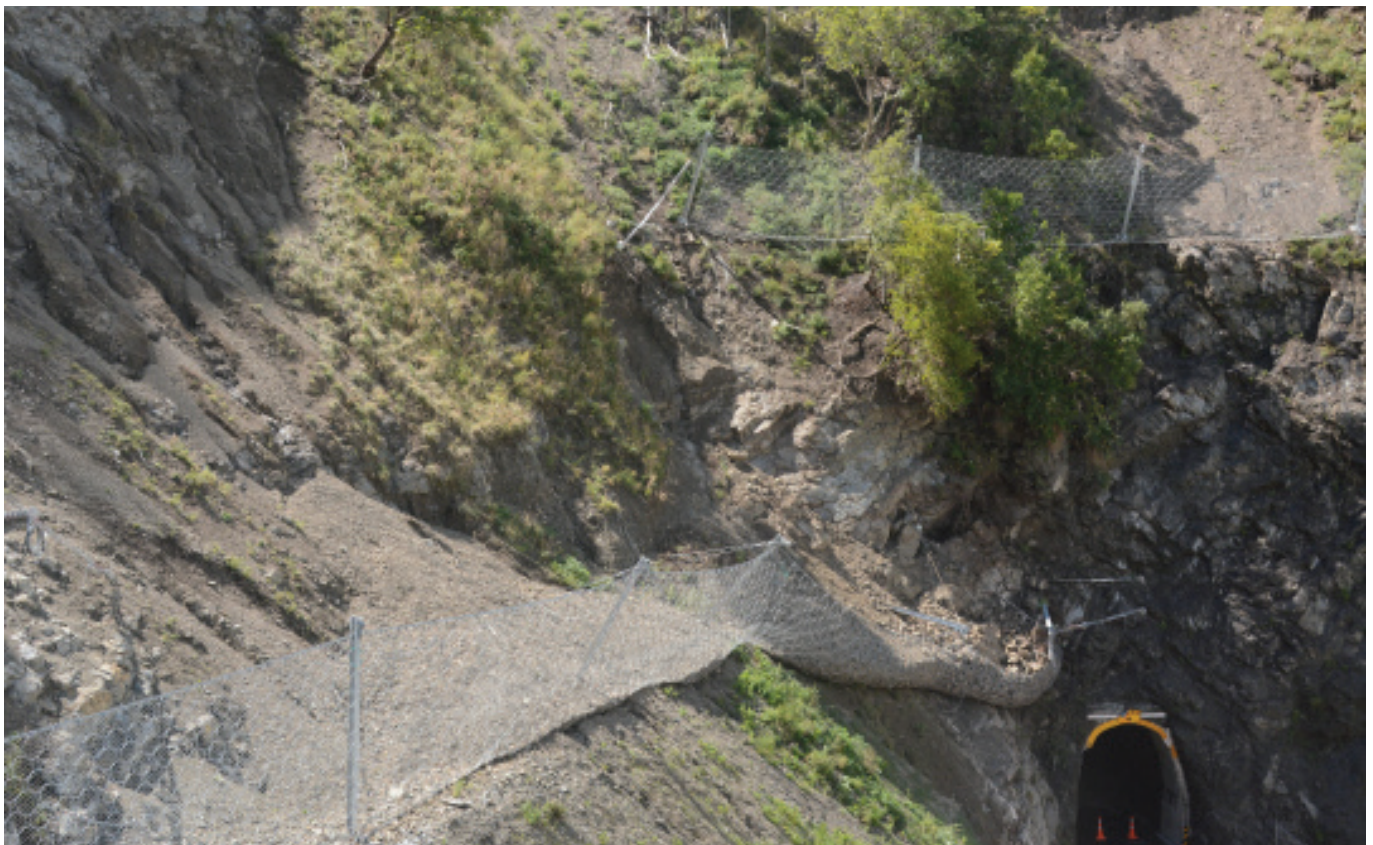
**RMC200A Fence**

Impacted fence after ex-cyclone Gita Feb 2018
