CCX-Mat™ Bulk Rolls

Putendo, Chile

CCX-M™ was used to eliminate water losses on an irrigation channel.

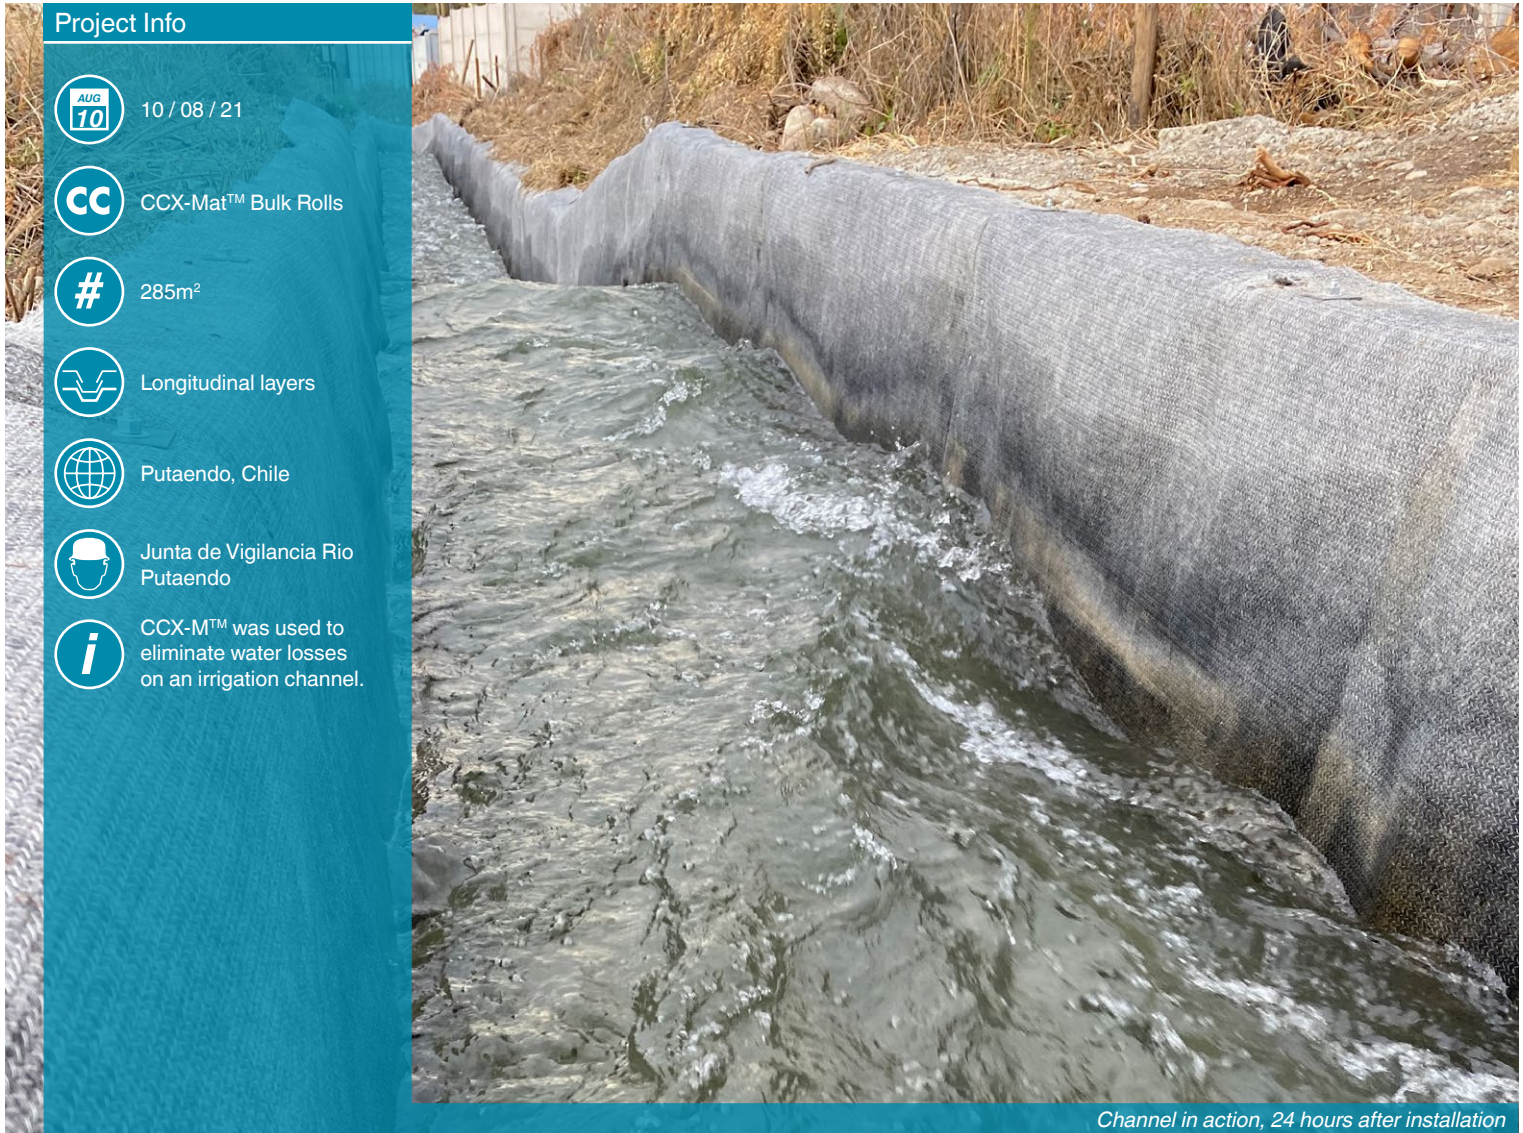
Channel in action, 24 hours after installation

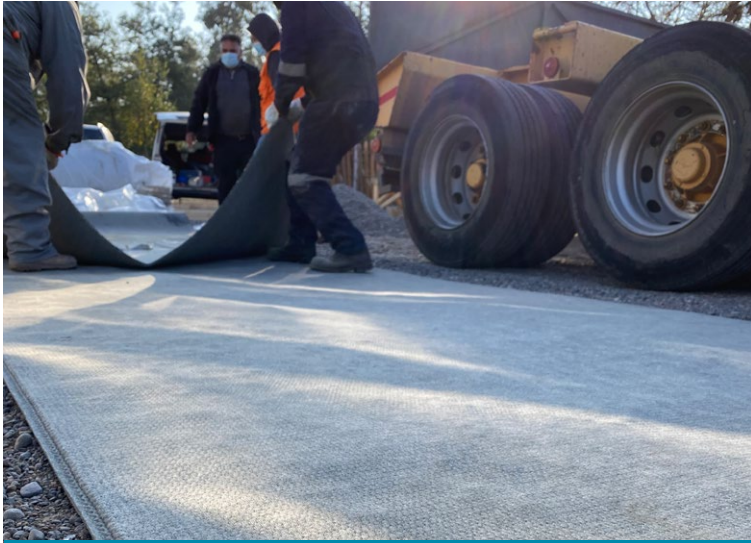
CCX-M™ being rolled out on site

285m² of CCX-M™ was installed in 2 shifts of 8 hours each by 6 people, in mild conditions. Traditional methods of installation would have taken approximately 21 days for the construction of 80m with a team of 10 people and heavy equipment.

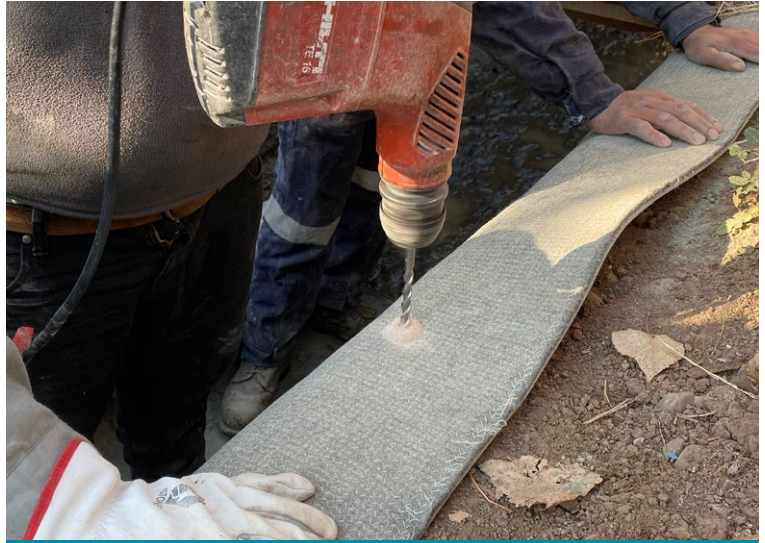
Holes being drilled for anchor bolt fixing

Holes and irregularities were filled with a low strength concrete mix to present an even surface ready for the application of CCX-Mat™ (CCX-M™). To fix and seal the CCX-M™ at the perimeter edges, expansive anchor bolts were installed on the shoulders and a flat steel bar was used at the start and the end of the channel, finished with epoxy grout to create an even transition. The overlap was thermally bonded and screwed at 100mm intervals with #8x3/4" stainless steel screws. These screws were short enough not to penetrate the 0.3mm thick LLDPE backing of the CCX-M™ underlap. CCX-M™ was hydrated with a garden hose 3 times to saturation.

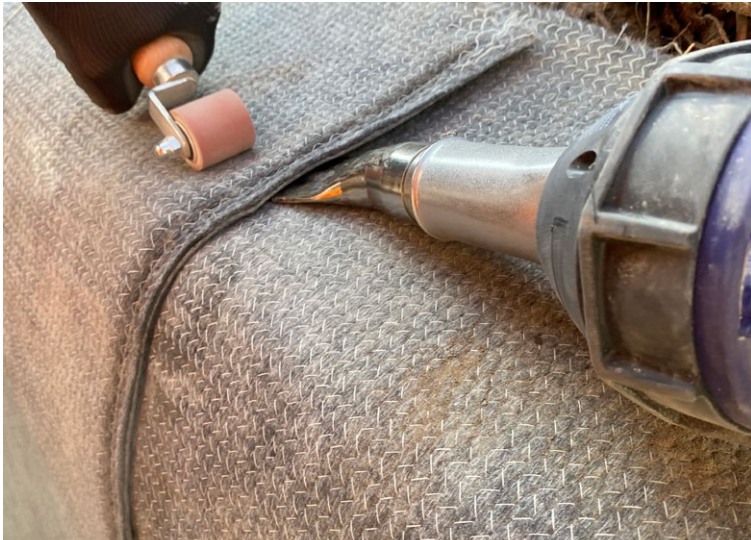
Thermal bonding overlap

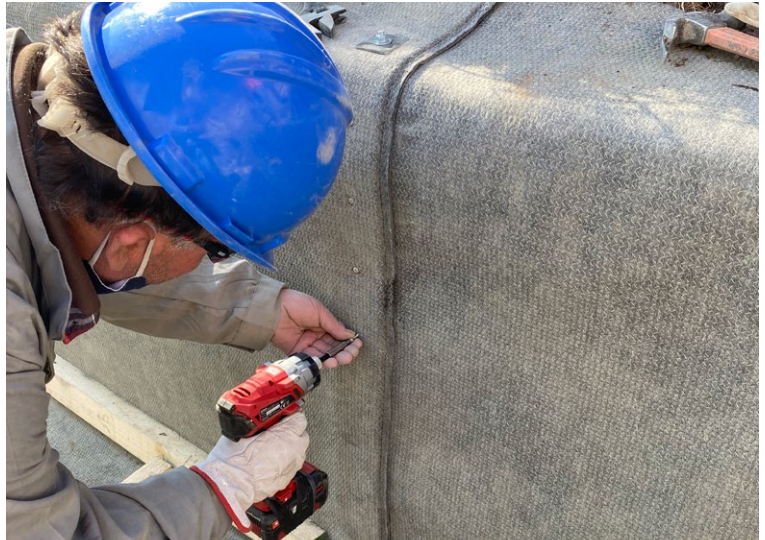
Screws are being fixed every 100mm

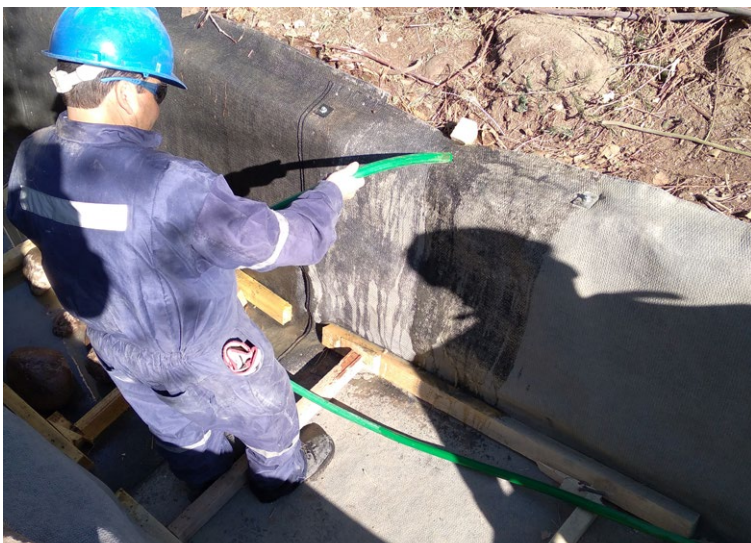
CCX-M™ being hydrated

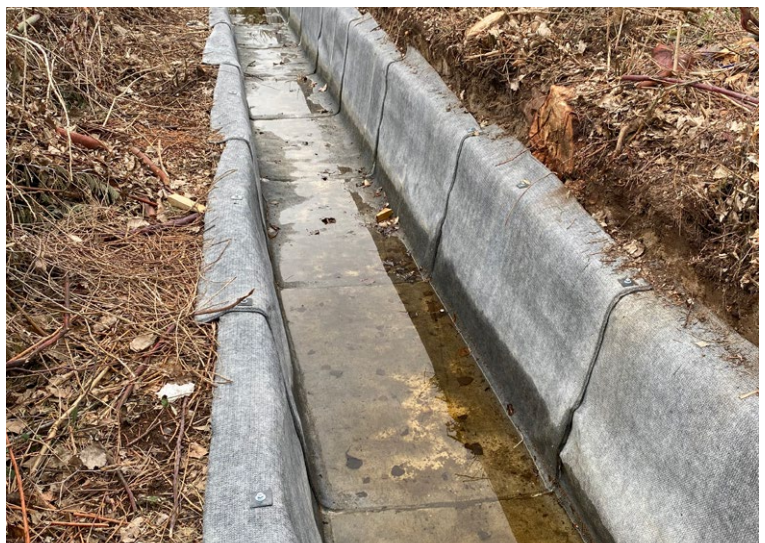
CCX-M™ Lined Channel in action

The project was deemed successful as the channel was rehabilitated in a very short period of time available with a reduced cost.
