CASE STUDY:

ROCKFALL BARRIER

Kaikoura SR27a & SR30

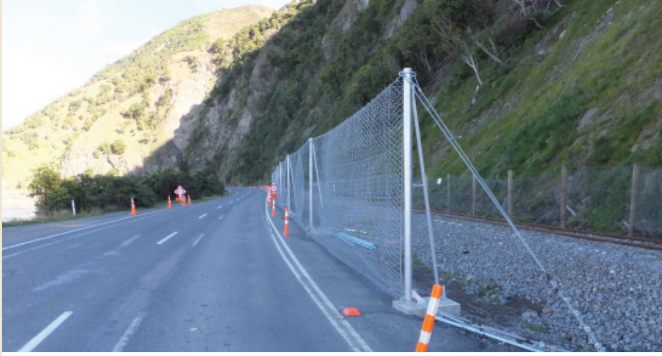
Safety in tight spaces

The rockfall fence was installed within a narrow space, protecting drivers from potential fall debris.

The best solution for these locations was a 100kJ ETAG27 certified fence at road shoulder beside the toe of the slope as it required little runoff area to provide good protection to passing vehicles.

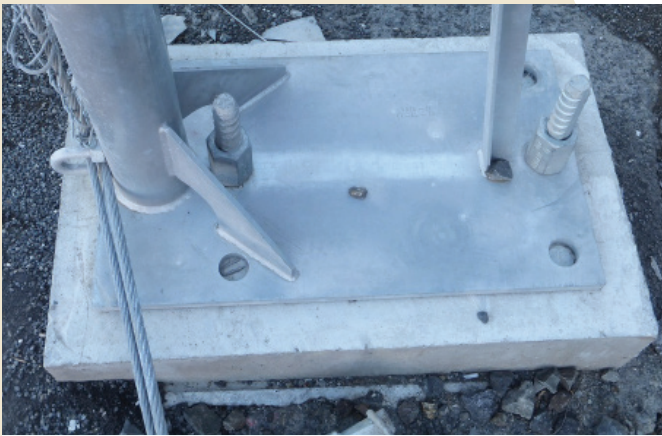
Up slope anchors not required

The RB100UAF fence system doesn't require up slope anchors, meaning it can be installed within a narrow corridor

RB100UAF (100kJ) fence is the lowest energy on offer with ETAG27 certification at the time of publishing this case study. It is a system without up slope anchors and therefore suitable for installation in constrained spaces. The light weight of the posts and intercepting panels makes it a very quick and economical system to install with no heavy equipment required.
