CASE STUDY:

SPORTSFIELD SLOPE EROSION

**GINGIN, WESTERN AUSTRALIA
MAY 2018**

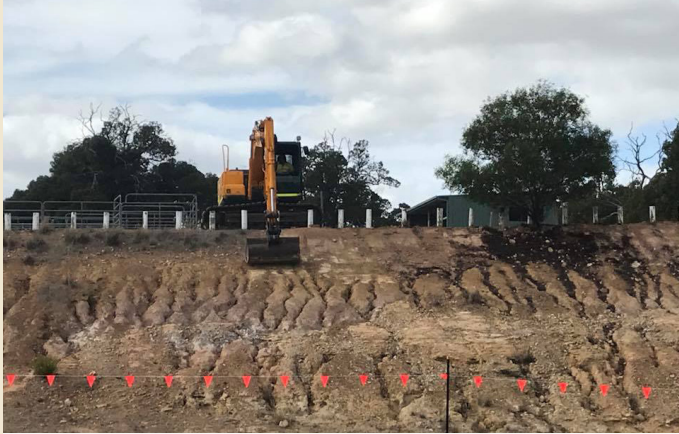
Severe rill erosion from surface run off on the slopes around the hockey field.

Geofabrics met with The Shire of Gingin on site to inspect the extent of the slope erosion issue that was occurring. Excessive rill erosion from surface runoff was prevalent on the slopes surrounding the hockey field. Rill erosion is the removal of soil by concentrated water running through streamlets, or headcuts.

Rills begin to form when the shear stress generated by the surface runoff is greater than the shear strength of the soil. This results in the surface runoff washing soil particles down the slope. The onsite discussion established that a permanent solution was preferred so that vegetation would not be solely relied upon to protect the slope in the future. An alternative solution was a biodegradable erosion control mat, however this was not seen as a long term solution to the problem.

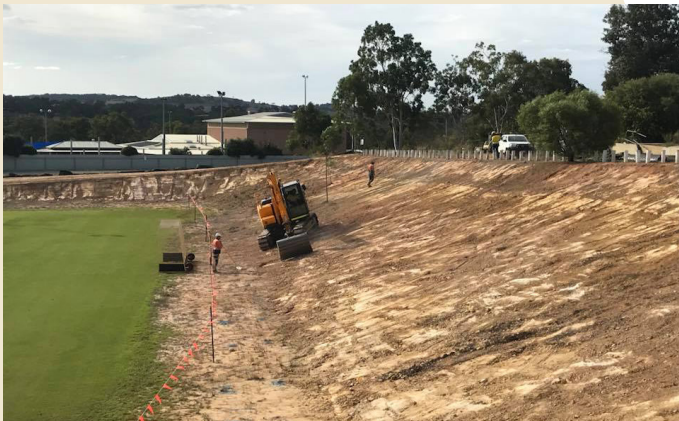
During slope re-profiling in preparation for the Grassroots.

Ground Stabilisation Systems Pty Ltd were contracted by The Shire of Gingin to carry out the installation of approximately 3,500 m² of Grassroots. Installation involved re-profiling the slope face to ensure that there was a smooth surface which was free from protrusions and vegetation. This preparation of the slope surface is important to ensure intimate contact between the soil and the Grassroots. The Grassroots was installed in an anchor trench at the top of the slopes and pinned at a rate of 3 pins/m² down the slope using 300 mm long mild steel U-pins.

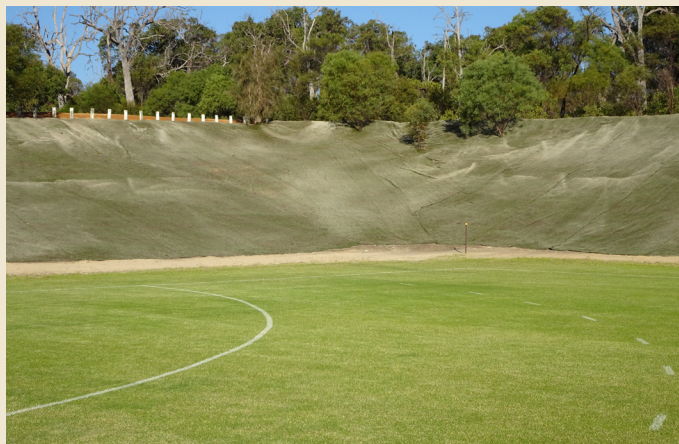
Completed installation in May 2018.

The installation was completed within two weeks. The Shire of Gingin and the local sports clubs are very satisfied with the outcome of the project.

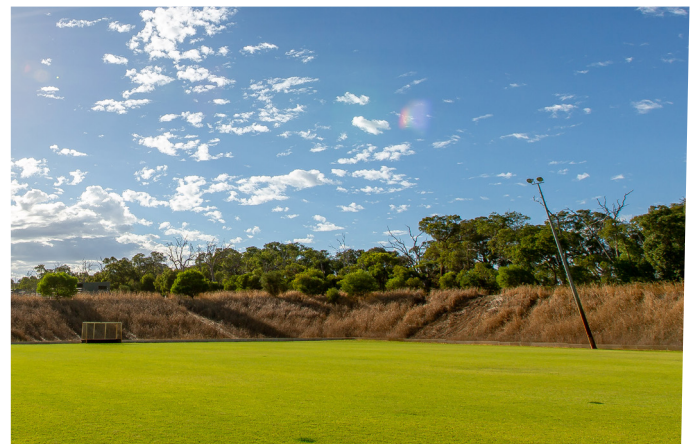
Photo taken in February 2019 of full vegetation regrowth on the slopes.
