CASE STUDY:

KULIJA RD EROSION PROTECTION

**ROCKINGHAM, WESTERN AUSTRALIA
AUGUST 2014**

CLIENT: CITY OF ROCKINGHAM

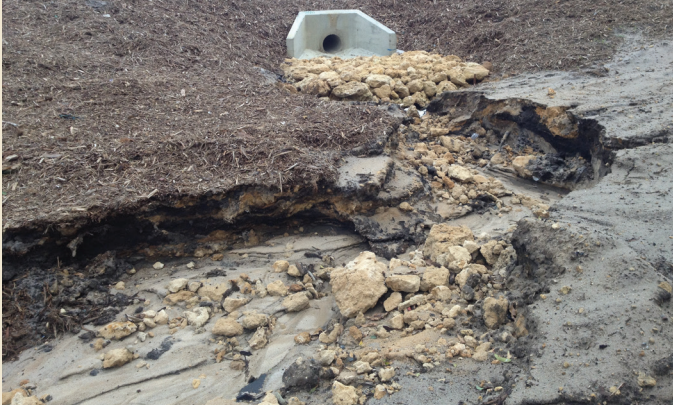
Outlet erosion before the solution

Erosion problems started to occur soon after completion due to an uncontrolled flow from a piped outlet system that was washing sand and soils down an 80 m long slope of approximately 8.75% grade causing major channel erosion. More erosion was occurring on road side embankment slopes due to water runoff from the unkerbed road travelling down embankment slopes next to the road.

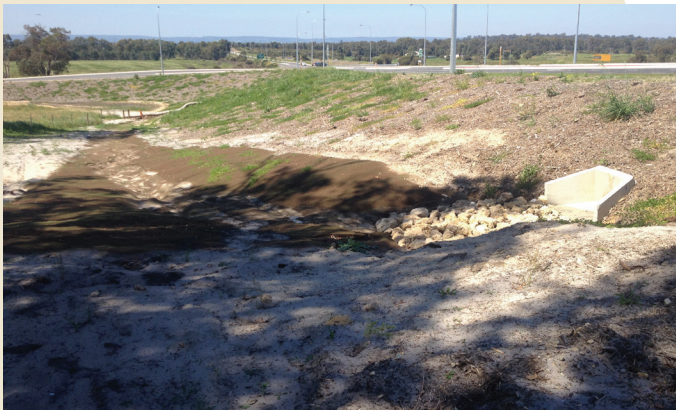
Completed install at drain outlet and 80 m slope

Following this visit, the use of Grassroots® turf reinforcement matting was proposed as a permanent solution that was preferred over other biodegradable and cellular confinement options. Grassroots® was an ideal solution due to being UV stable and protecting the underlying soil from high velocity water flows whilst also having the benefit of promoting grass to grow, allowing it to blend seamlessly into the environment.

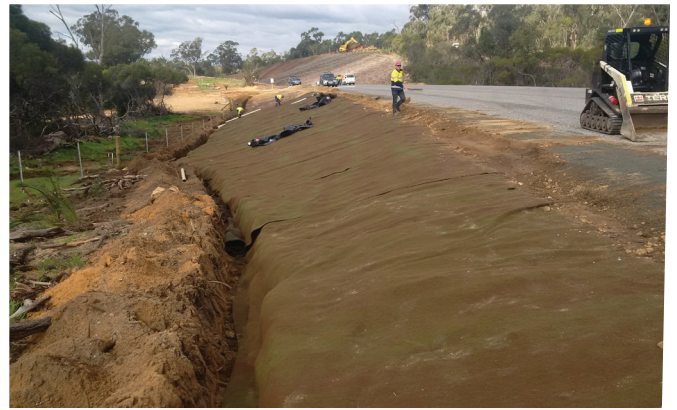
During installation in 2014

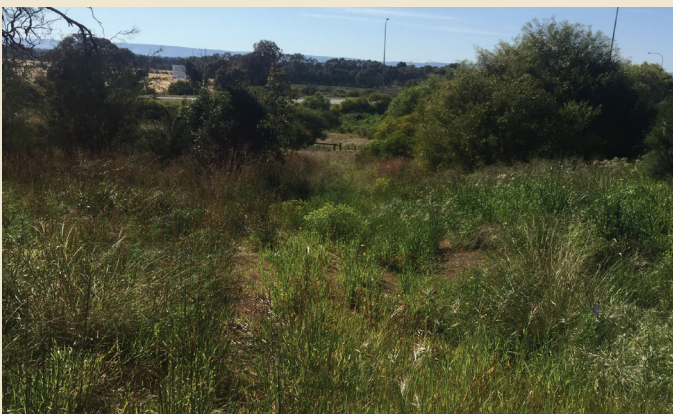
The same spot as above photo upon revisiting in September 2018

Geofabrics visited the project location in September 2018 to see how this solution has performed over a long-term period. The results are fantastic with no erosion occurring with the added benefit of vegetation establishing and thriving.

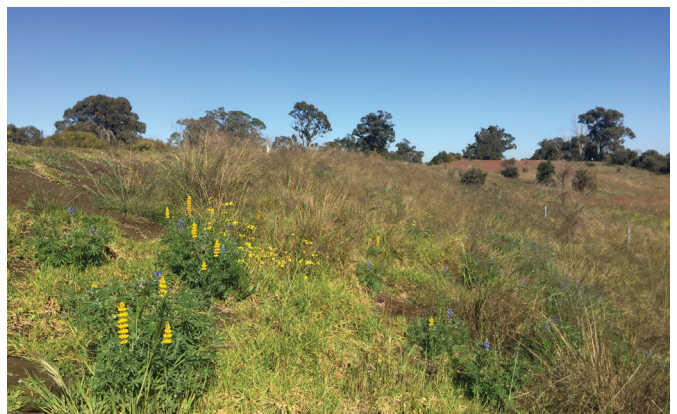
The same spot as cover image in September 2018
