CASE STUDY:

PAVEMENT REHAB & RECONSTRUCTION

**BLACKBURN, VICTORIA
JANUARY 2019**

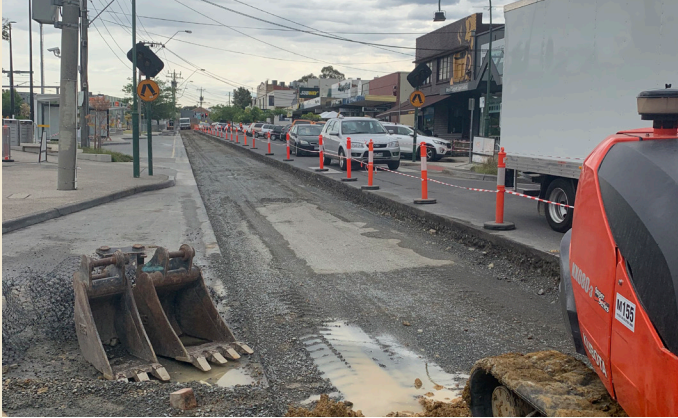
Council then engaged Tensar whom forwarded the concerns back to Geofabrics. Geofabrics met with the council, contractor and engineer to inspect the site, it was noted and obvious that the subgrade appeared to have a far less CBR value than the 4-5% that the design was based on.

Soft subgrade after first attempt of compaction prior to the bidim and Tensor TriAx Tx160.

Geofabrics advised that in the soft areas, further excavation would be required (suggested additional 150 mm) a separation geotextile (bidim A24) be placed over the subgrade, crushed rock base be placed over the top, once compacted and level, lay the Tensor TriAx Tx160 and then add the 150 mm class 2 crushed rock and asphalt.

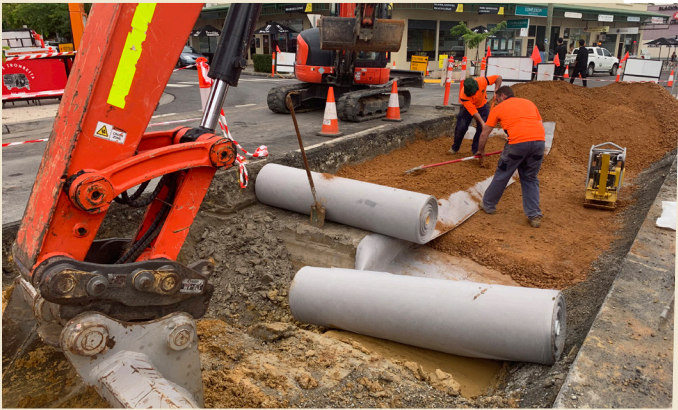
Additional excavation and install of bidim separation.

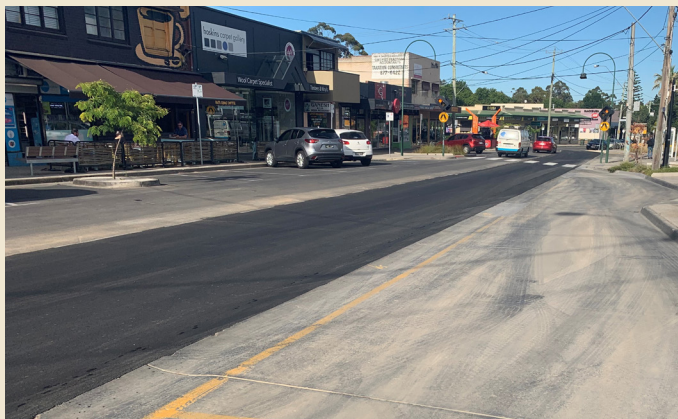
Completed road and bus turn-outs.
