CASE STUDY:

ROSEBERY TAILINGS DAM

ROSEBERY, TASMANIA, AUSTRALIA

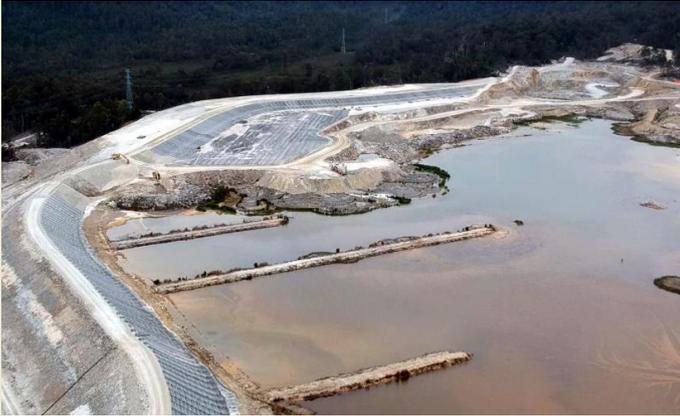
> Tailings Dam

Geotas installed 190,000 m² net area of the Teranap 531 liner and 250,000 m² of upper and lower bidim cushioning geotextile.

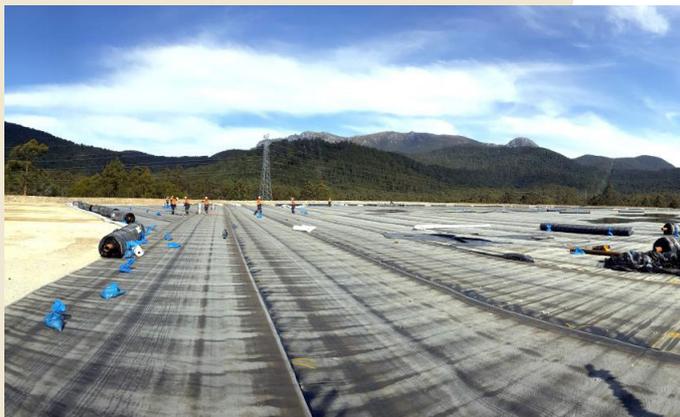
This bank of 6,000 m² took one day to install.

Conditions during construction were very challenging, with over 1 metre of rain during the first month alone, high wind events, and snow. Geotas, with the help of Aeramix Pty Ltd, developed efficient methodology for the deployment of the liner, including a specially constructed hydraulic spreader bar attached to a 36 ton excavator, which was used to pick up the 1,800 Kg rolls, and accurately place the liner with a 200 mm overlap. This enabled installation of over 6,000 square metres per day, when conditions allowed.
