# CASE STUDY

Double Twist Mesh

Project: Bryants Bridge Dropout Repair SH57  
Date: January 2007  
Client: NZTA  
Location: Palmerston North

## Green Terramesh

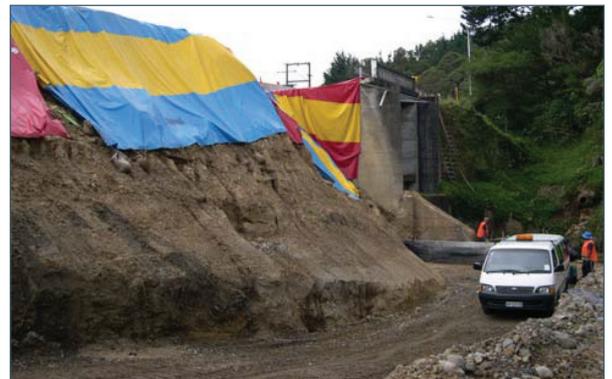
Site prior to Construction

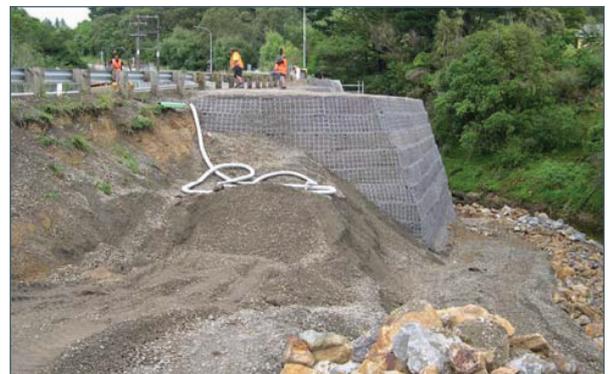
Construction of Green Terramesh structure

The design considered a mix of **Tensar RE** geogrid grades located at each 0.6m vertical lift of the **Green Terramesh** facing units. **Enkadrain**, a geocomposite drain, was used up against the cut face at the rear of the reinforced soil zone to cut off the path of groundwater. Subsoil collector drains located at the base of the cut slope ensured any excess groundwater collected by the **Enkadrain** was quickly removed away from the structure.

The final **Green Terramesh** structure was 11m in height and 25m in length. After receiving onsite training from Geofabrics the contractor was able to develop a construction methodology which included the use of 2 Geofabrics supplied pneumatic lacing tools. Working day and night shifts they completed the structure within 5 days. This high level of performance by the contractor ensured that the traffic disruption was kept to a minimum providing a great result to the client and road users.

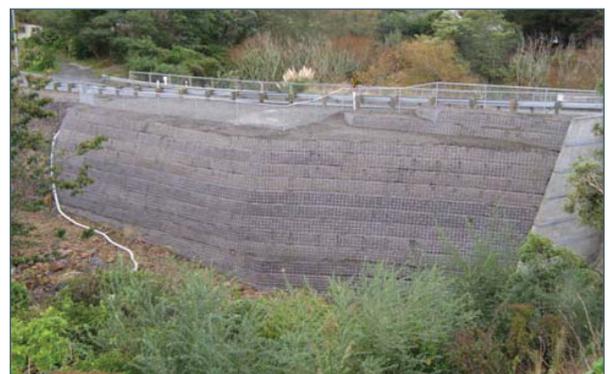
Completed Green Terramesh structure at Bryants Bridge
