CASE STUDY:

Te Ana Marina

LYTTELTON HARBOUR, CHRISTCHURCH
AUGUST 2017
CLIENT: MARITIME SPECIALIST SERVICES LTD/
FULTON HOGAN

SILT CURTAIN

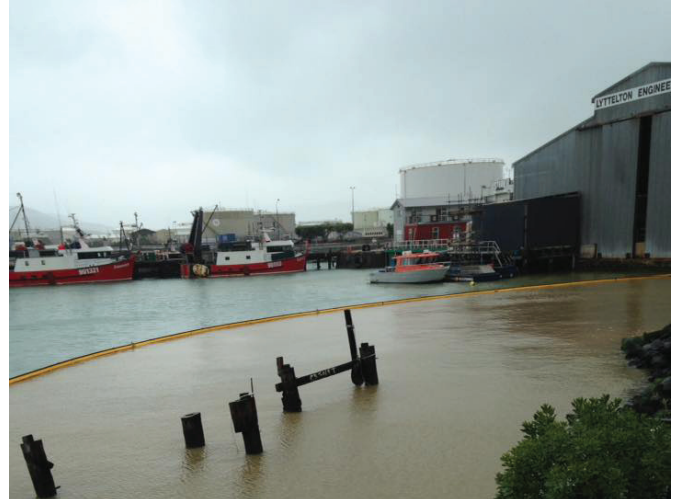
Silt Curtain in Use

Silt curtain retaining sediment within the protected area

The curtain was installed in early August and it was tested three days later during a heavy rain event in which significant volumes of sediment entered the protected area through a stormwater outlet. The curtain was proven to be extremely effective in retaining the sediment in the work area, thus giving the suspended sediment time to settle to the bottom.

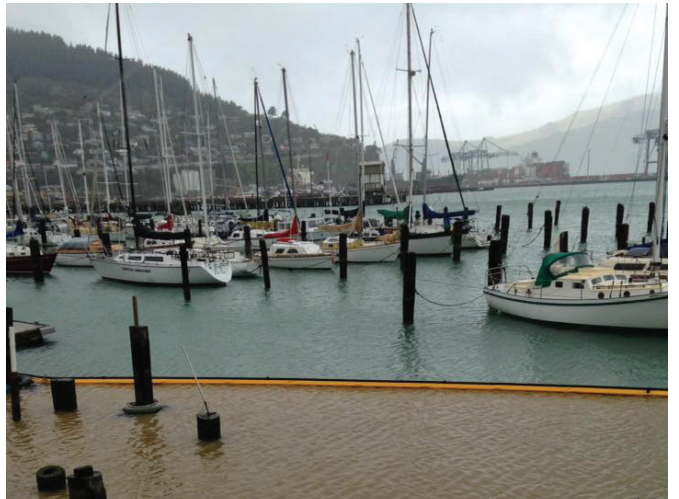
Silt Curtain in Use

Effective management of sediment-laden stormwater runoff
