# CASE STUDY

Geogrid

Project: Kawakawa Bay Landslide  
Date: Jan - May 2009  
Client: Ministry of Education  
Location: Manukau City

## Miragrid GX Geogrid

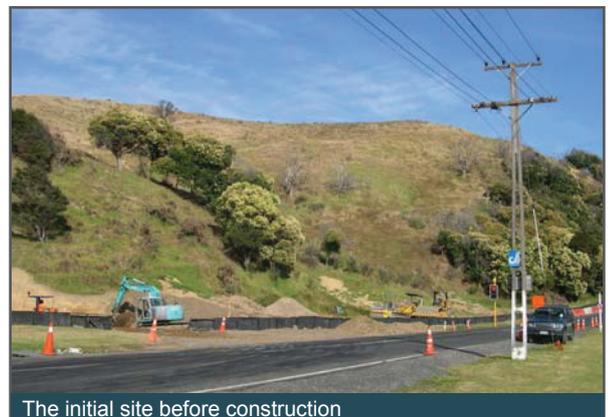
The initial site before construction

In July 2008, high intensity rainfall events triggered landslips across the North Island. One such slip occurred at Kawakawa Bay in early August 2008. Initially approximately 500m<sup>3</sup> of slip debris fell from the top of a cliff face and blocked the Clevedon to Kawakawa Bay Road, with the debris sliding over and exposing the underlying local greywacke base rock.

Tension cracks and a head scarp feature were identified enveloping a house platform 100m back from the cliff face and it very quickly became apparent that a major deep landslide was affecting the whole of the hillside and cliff face. Daily survey of surface monitoring points confirmed that the landslide was active in the then prevailing wet weather conditions with accelerating movement of the order of up to 30mm per day (total displacements of the order of 500mm). Assessments of the potential run-out distances from the very large mass of the landslide (estimated at 400,000m<sup>3</sup>) indicated that at least five occupied dwellings at the foot of the hillside were potentially at risk of inundation with debris.

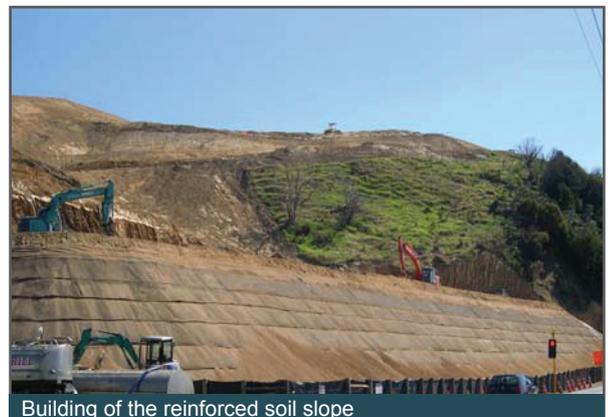
Building of the reinforced soil slope

Speed of construction was paramount to stabilise the hill side and stop a further landslide. The **Miragrid** geogrids met the design requirements and were readily available for the start of construction in late January 2009. With the wide roll widths at 5.2m this enabled the contractor to save time and money with a decrease in installation time. By utilising the biodegradable **Biomac Grasstrike** in the front face of the wrap around buttress structure a green finish was achieved restoring the hill (as close as possible to its original state).

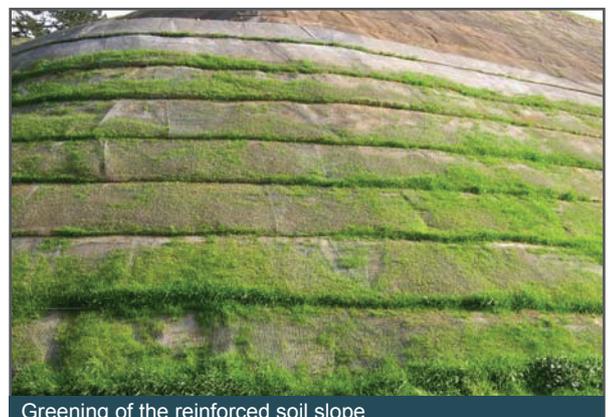
Greening of the reinforced soil slope

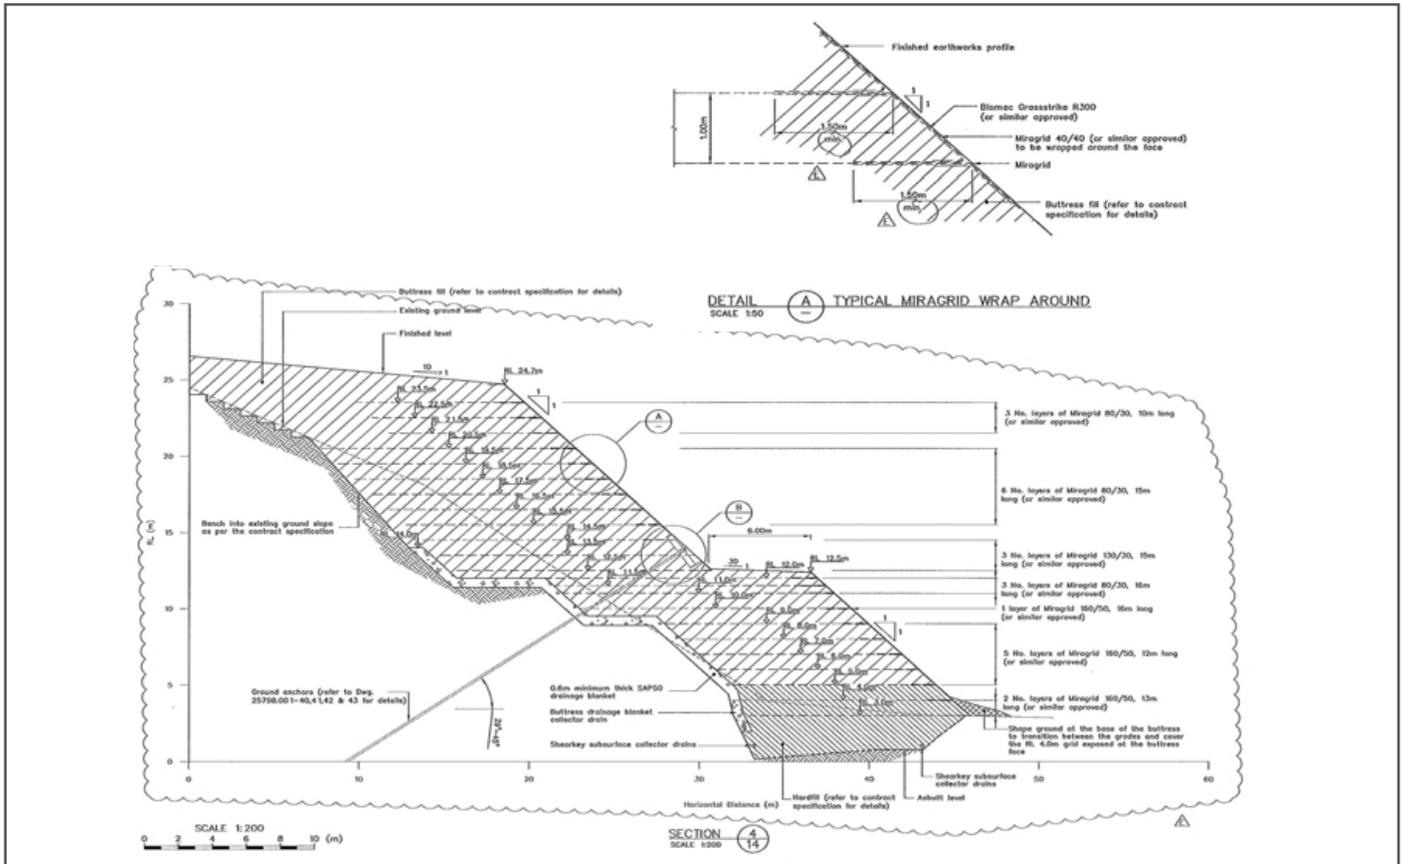
Typical Buttress Section Details (the source of the drawing details is from Tonkin & Taylor Construction Drawings)

- The removal of 100,000m<sup>3</sup> of earthworks to unload the top of the landslide thus reducing the driving force.
- Building a geogrid reinforced soil buttress at the base of the landslide.
- Drainage to lower the ground water pressures beneath landslide
- Ground anchors to restrain movement of the landslide.

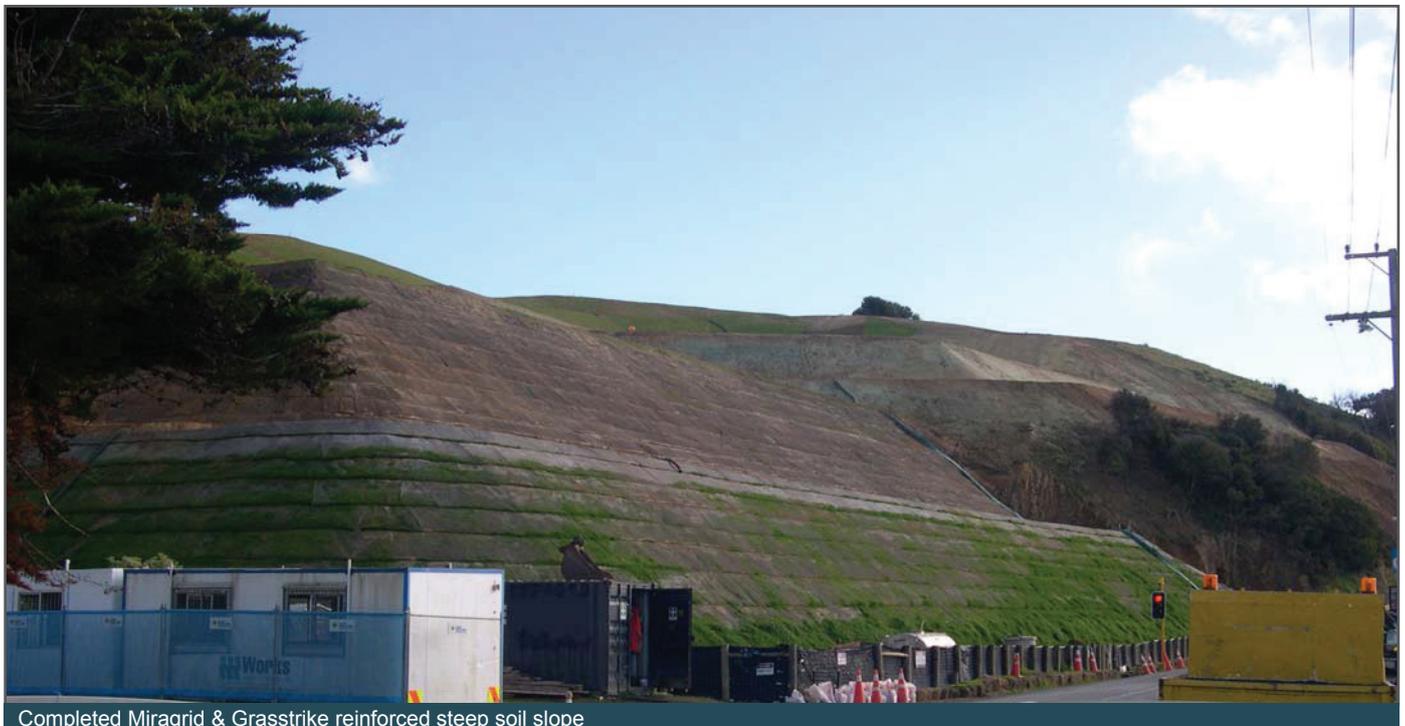
Completed Miragrid & Grasstrike reinforced steep soil slope
