CASE STUDY

Rockfall Products

Project: Piripaua Barrier Fence
Date: June – July 2010
Client: Genesis Energy
Designer: Tonkin & Taylor
Location: Waikaremoana

Barrier Fence

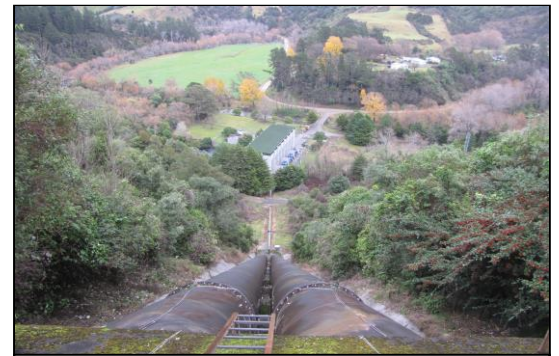
Existing Penstock line needing protection

A tension crack was observed on the access track leading to the Piripaua Penstock. Engineers Tonkin & Taylor were engaged to carry out investigation work and to provide a proposal to prevent damage to the penstock from a potential debris flow should there be a failure of the uphill slope.

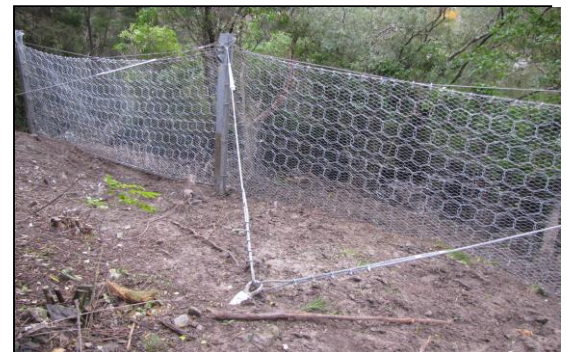
2000kJ Energy Rating Barrier Fence

Maccaferri CTR20/04/A 2000kJ energy barrier is ETAG 027 compliant (Guideline of European Technical Approval of Falling Rock Protection Kits). This indicates that the fence has undergone rigorous full scale testing to comply with the European requirement under the energy rating capacity. Geofabrics is able to provide ETAG 027 certified barrier fence from 500kJ to 8,500kJ.

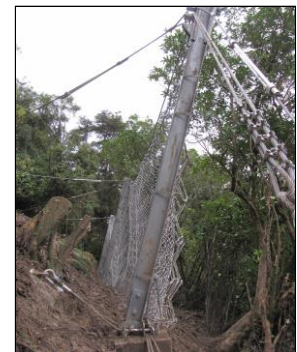
2000kJ Energy Rating Barrier Fence
