## GEOFABRICS CASE STUDY

# HIGH-PERFORMANCE GEOTEXTILE SOLVES WEBER ROAD SUBGRADE ISSUES

## PROJECT DESCRIPTION

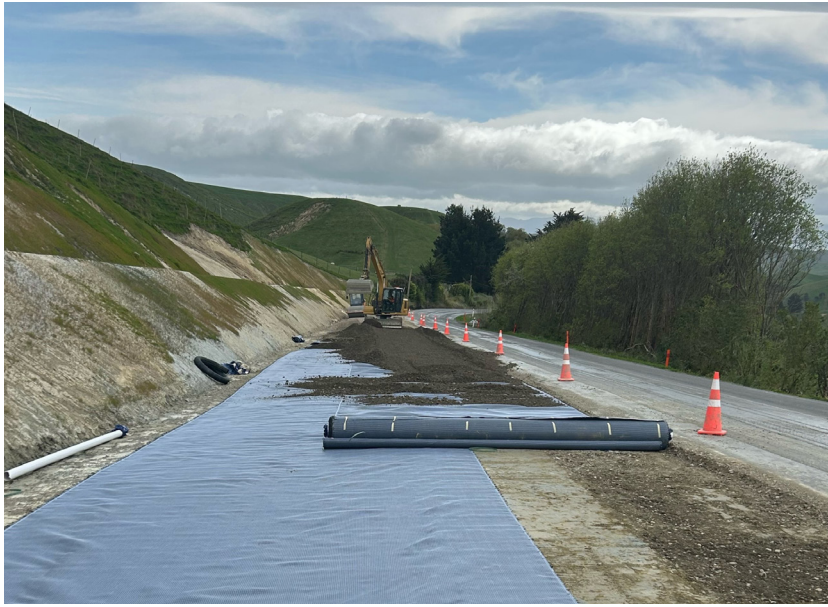
# Moisture control and subgrade stabilisation

**6,750 m<sup>2</sup>**  
**H2Rx**  
installed

To prepare the ground for installation, light grading was undertaken to remove surface irregularities, with care taken to avoid using heavy equipment that might disturb the soft subgrade. Mirafi H2Rx geotextile rolls were then installed along the alignment using light machinery. The geotextile was laid in the direction of traffic flow, with longitudinal seams overlapped by 300 – 450 millimetres and cross-roll overlaps staggered to minimise potential weak points.

A total of 6,750 m<sup>2</sup> of H2Rx geotextile was installed to evenly distribute loads and reduce deformation across the soft, moisture-sensitive subgrade. Its unique wicking action continuously draws moisture away from the road base, preventing saturation and protecting the pavement's structural integrity. This transformed the site into a durable, high-performing roadway that effectively addressed the initial ground conditions.
