GEOFABRICS CASE STUDY

CONCRETE CANVAS ENHANCES DRAINAGE EFFICIENCY & STABILITY AT WAIKAWA BAY

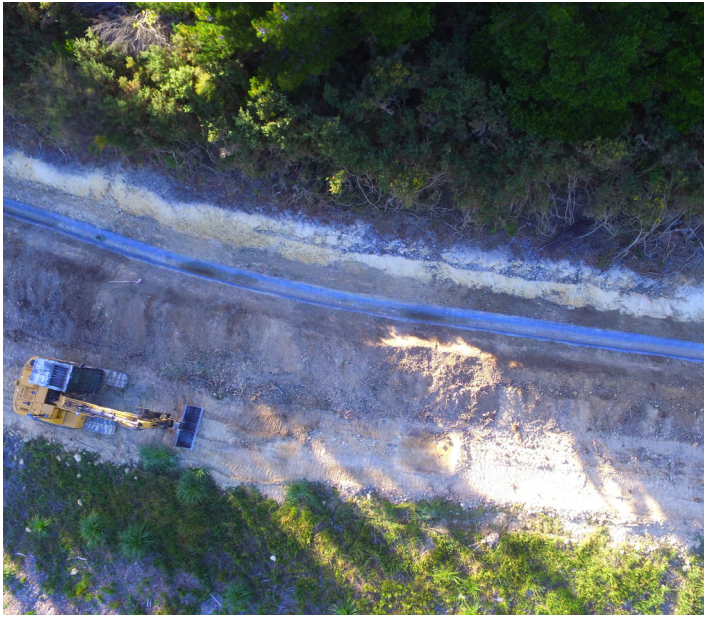
1.5 x 230m
long drain

To simplify the installation process, the contractor, Crafar Crouch Construction, chose to create the formwork needed to shape both the drain and the sides that required trenching. This formwork was attached to the end of a digger and cut into the shape required for the drain. The total width of the drain was 1.5 metres, with a length of 230 metres, and included 150mm overlaps at the joins. Concrete Canvas CCX-U was laid along the drain to minimise any wastage and overlaps. Geofabrics provided installation training and assistance, including on-site support.

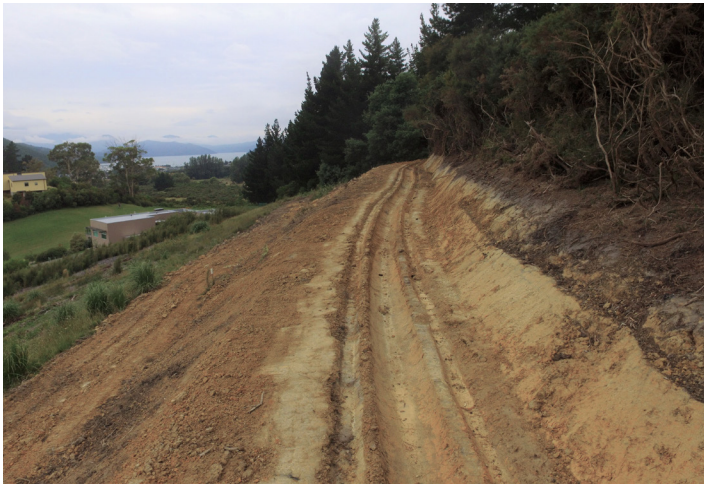
Adapts
to the surface
of the drain

The Geofabrics team recommended using Concrete Canvas CCX-U over shotcrete due to its numerous benefits, including fast installation and versatile application. Concrete Canvas easily conforms to the surface of the drain and offers simple deployment along a sloped surface.
