CASE STUDY:

BRIGHTON BEACH GROYNES

**BRIGHTON, SOUTH AUSTRALIA
FEBRUARY 2017**

CLIENT: CITY OF HOLDFAST BAY

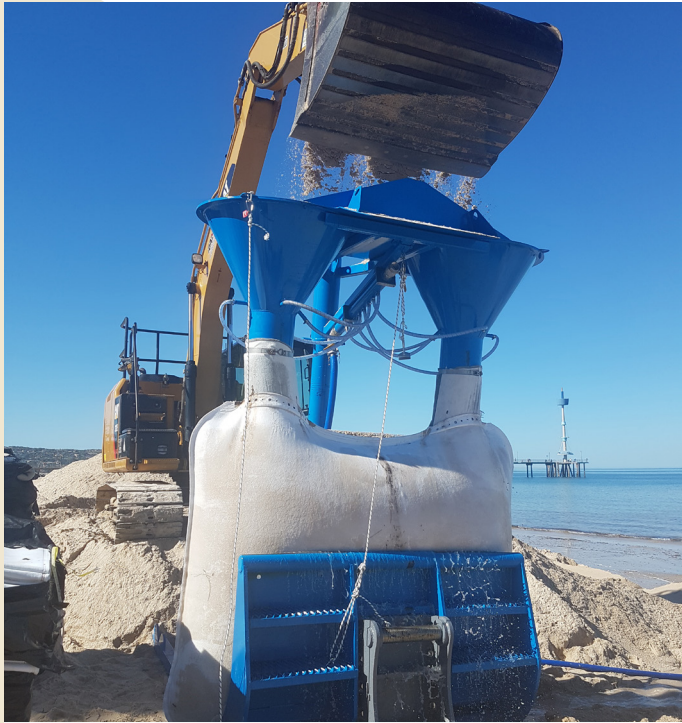
Filling the Elcorock sand containers

The two groynes were approximately 30 m long and spaced 50 m apart. Each groyne was made of 50, 2.5 m³ Elcorock sand containers.

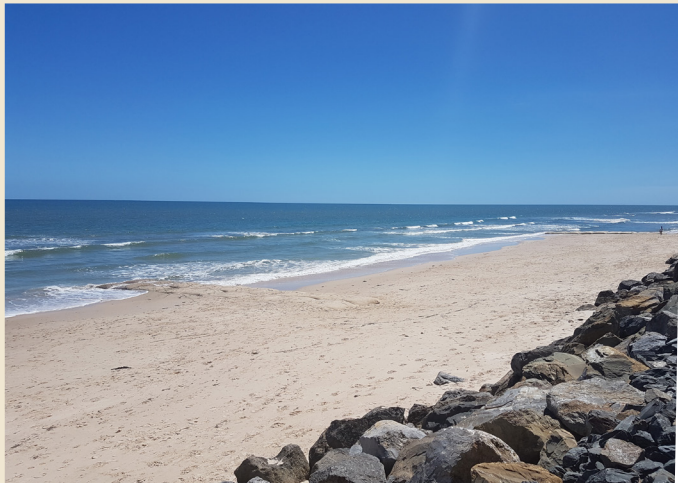
Completed Elcorock groynes blending to the beach in 2017

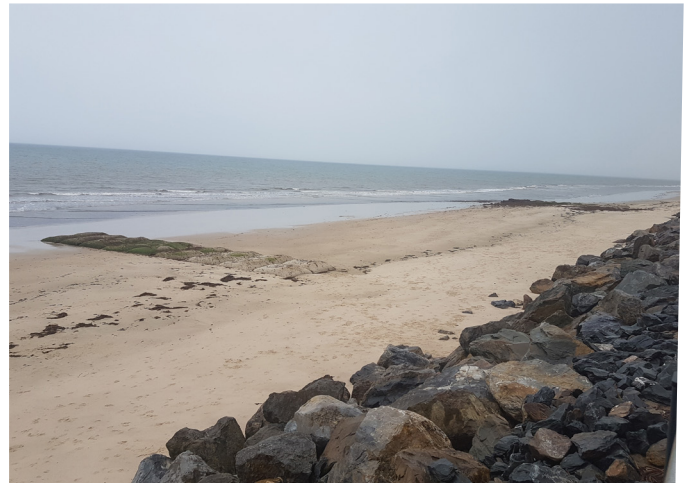
Elcorock Groynes at the end of 2018 after Winter. Historically, the beach at this time of the year was near non-existent, however the bags are working extremely well, capturing sand and thus building up the beach.

Two years later and the beach is looking great with significant build-up of sand occurring, having protected the rock wall and road. With no visual damage to the sand bags, the council is extremely happy with the result and has gained funding for two more groynes in the coming months.
